SGS Report No.:MSRCZ2400044-01A

TESTING REPORT

Principal Name: BESTON GROUP CO.,LTD.
Principal Address: NO.99 South University Road, Zhengzhou City, Henan Province, China.
Declared Sample Name: Pyrolytic carbon black
Sample Received Date: 2024-01-23
Sample Testing Period: 2024-01-23 ~ 2024-01-31
Declared Sample Number: /
Sample Condition on Receipt: Solid (1954g)

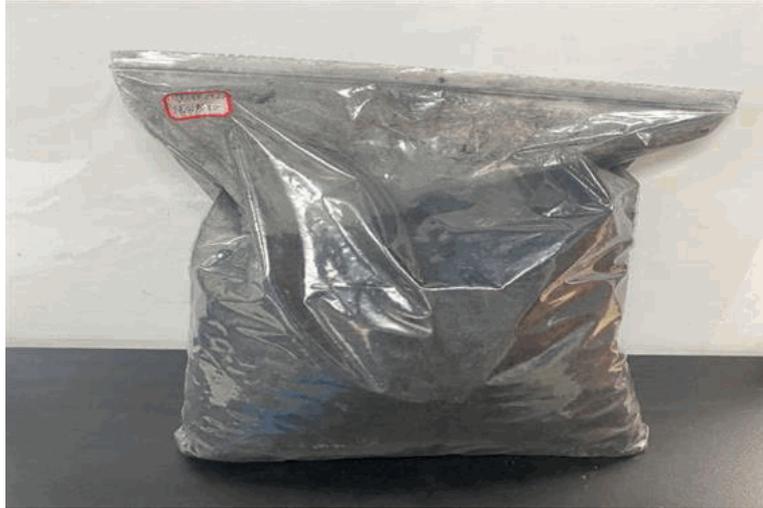
MNT240280CZ.001

Sample photo:
